# South Zumbro Watershed

## Storm Water & Capital Improvement Plan

### Olmsted and Dodge Counties

September 2003

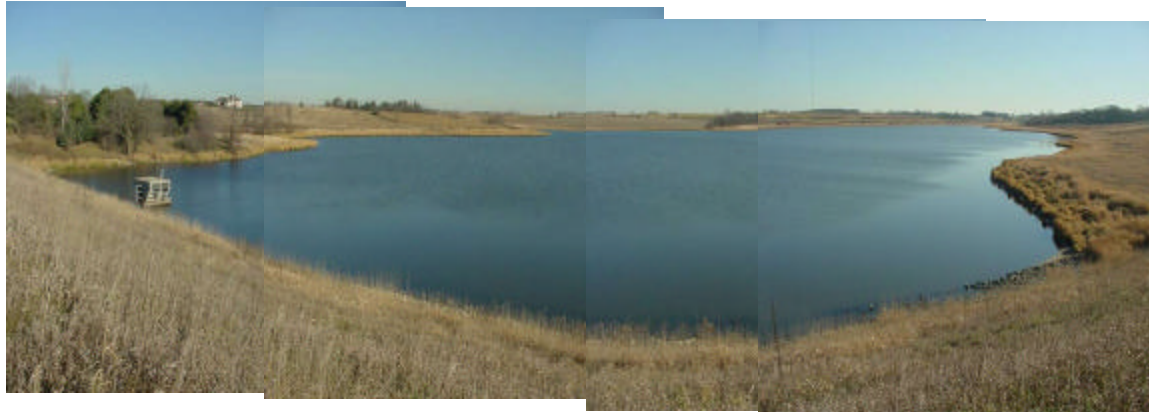
***This reservoir was built for Silver Creek (SR-2). With a wet pool area of about 98 acres serving a 9.90 square mile drainage area, the reservoir attenuates flows to a maximum of 135 cubic feet per second for greater than 100-year storms.***

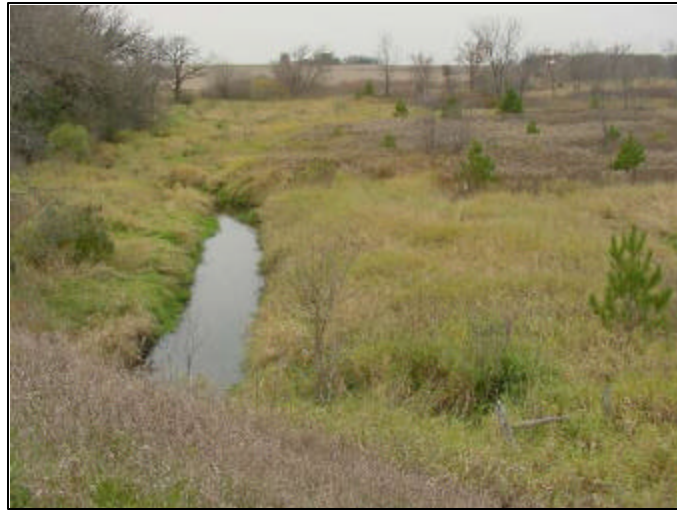
A watershed-based approach is proposed as a basis for appropriately sizing bridges, taking into account the natural flow attenuation (slowing and reducing) function of the existing floodplain areas in the stream corridor (illustrated in the photo on the right). This plan focuses on the bridges listed in the Capital Improvement Plans of Olmsted and Dodge Counties to:

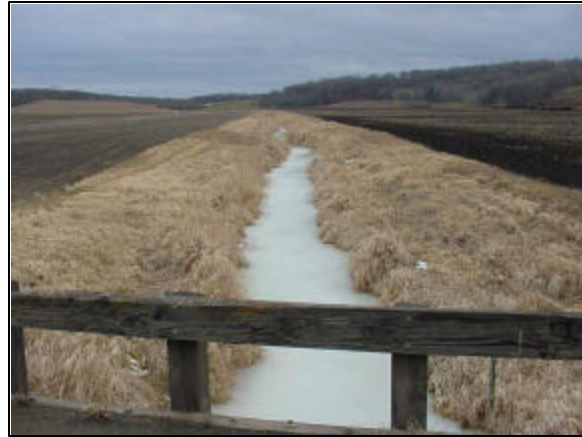
In general, changes in agricultural practices have impacted many wetlands or natural flow-attenuating floodplains in the watershed. For example, row crop agriculture in floodways (illustrated in the photo on the right) and its associated tile lines, has increased wetland draining. As a result, water retention (sponge benefit of wetlands) in the watershed has decreased, increasing waterway peak flows.

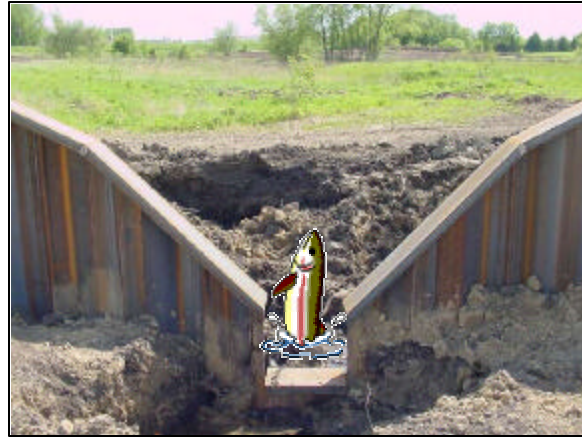
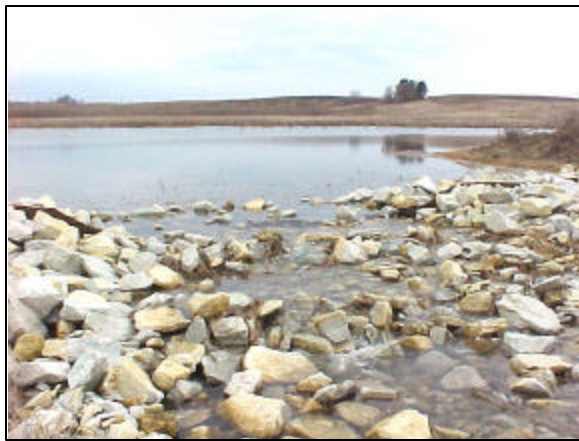
The photo at left illustrates how this type of structure operates after a storm. Notice that the sheet-piling is almost completely covered by the riprap used to stabilize the weir structure. Furthermore, the structure blends into the

natural environment, as illustrated in the photo on the right.

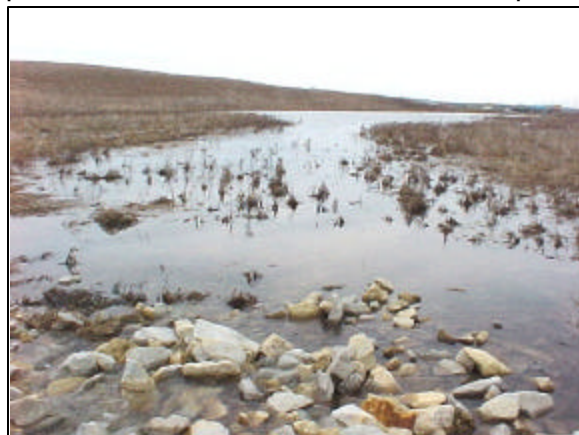
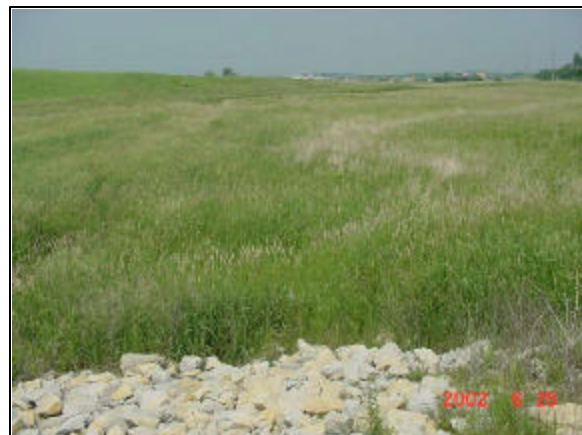
These flow control structures are designed to use the existing floodplain to attenuate the frequent 1 to 3 inch storms. After the storm runoff recedes, the area does not maintain a water pool and returns to dry or base flow conditions. These high water and normally non-ponded conditions are illustrated in the photos below.

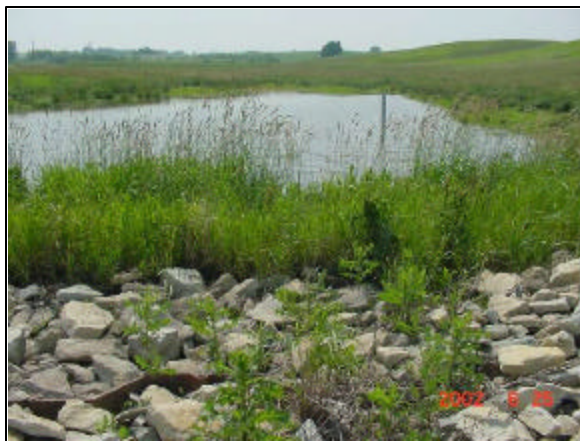
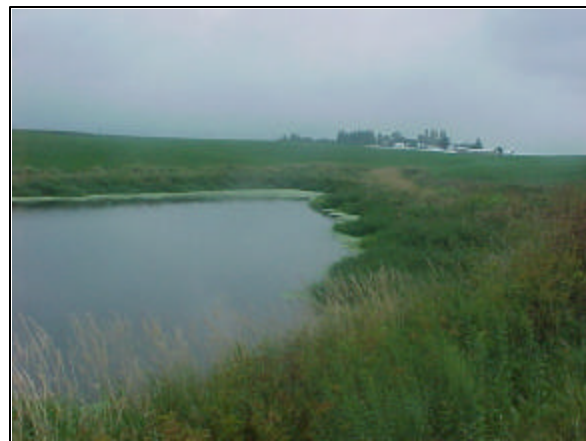
The flow control structures can be associated with the establishment of farm ponds, as illustrated in these photos: an NRCS pond in Elmira Township (*right*); ponding associated with wetland restoration in Kalmar Township (*bottom left*); and a NRCS pond in Haverhill Township (*bottom right*). When a farm pond is desired, it becomes a by-product of the borrow pit for the material to construct the berm. Otherwise, this material can be obtained from areas that will not result in open water.

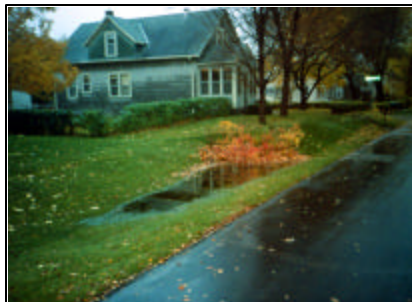
*At left: Photo taken after 3.5 inches of rain fell in less than an hour late one afternoon.*

*At right: The morning after the storm, all water has been infiltrated.*

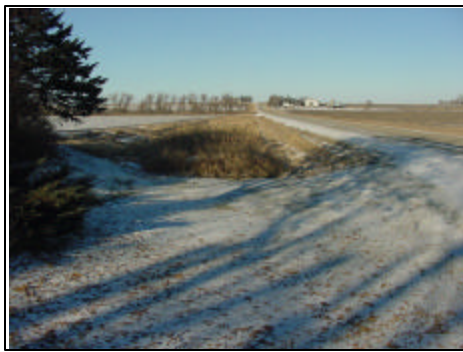
*Photo 3 -- Dodge County Road 9*

Comments: Highly visible with potential aesthetic value. Large amounts of sand and salt are applied along the roadway. Drainageway flows to Cascade Creek. It is recommended that Olmsted County contact Mn/DOT about establishing a joint demonstration project.

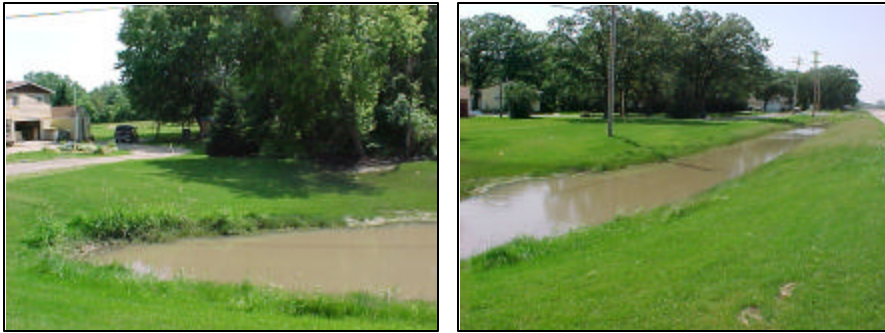
*Photo 1 -- CSAH 36 and 20th Street SE (1900 Block in Marion Township)*

Location: CSAH 36 and 20th Street SE (1900 Block in Marion Township)(see Photo 1), Olmsted County.

Comments: A highly visible residential area in Marion Township along CSAH 36 (Marion Road). Large amounts of sand and salt are applied along the roadway. Residential complaints about localized flooding of property; may require additional BMPs. Rain garden would be an aesthetically pleasing solution that residents would likely accept. Waterway flows to Bear Creek.

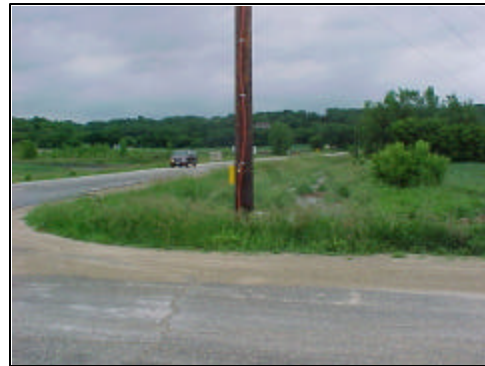
*Photo 2 -- CR 124 and 48th Street NW*

Erosion and sedimentation along this creek have created maintenance problems at the intersection with County Road 124 (Hadley Valley Road).

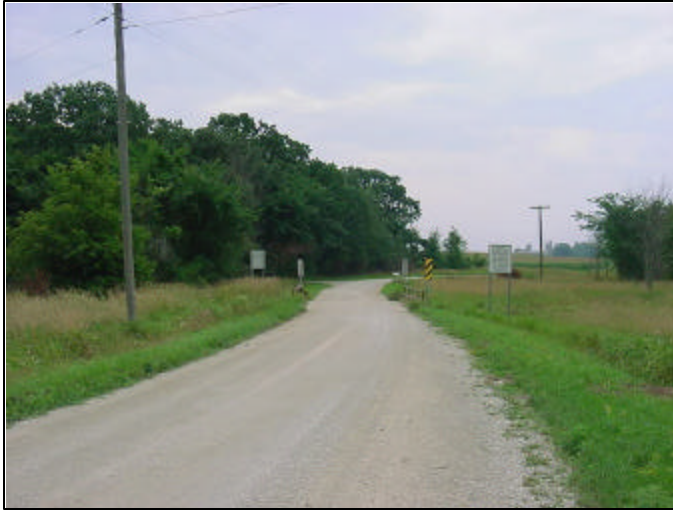
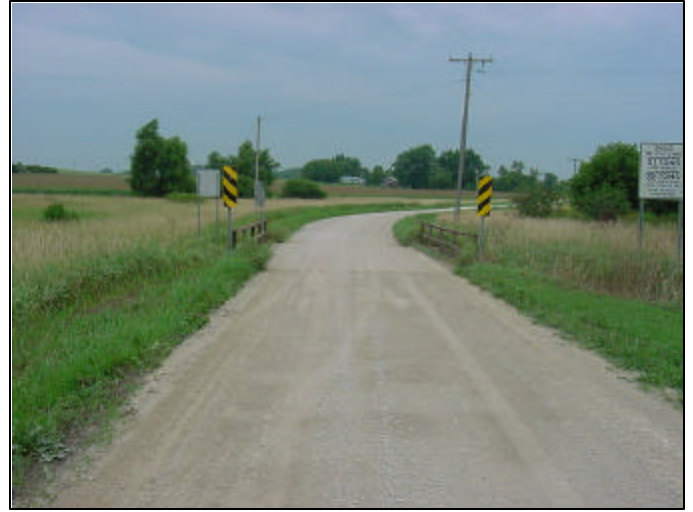
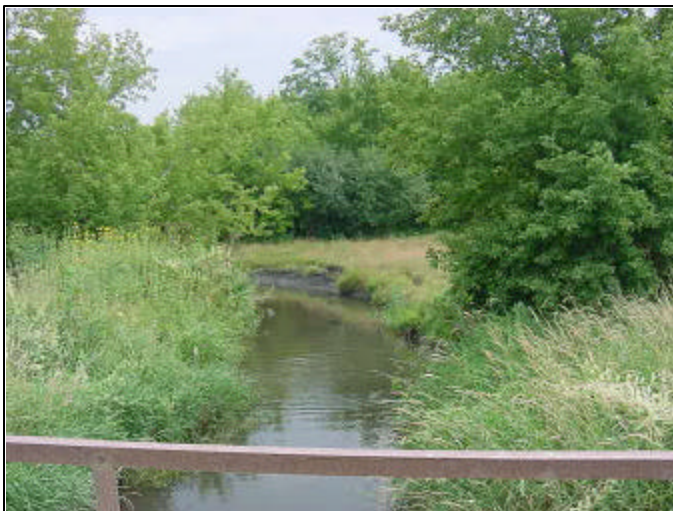
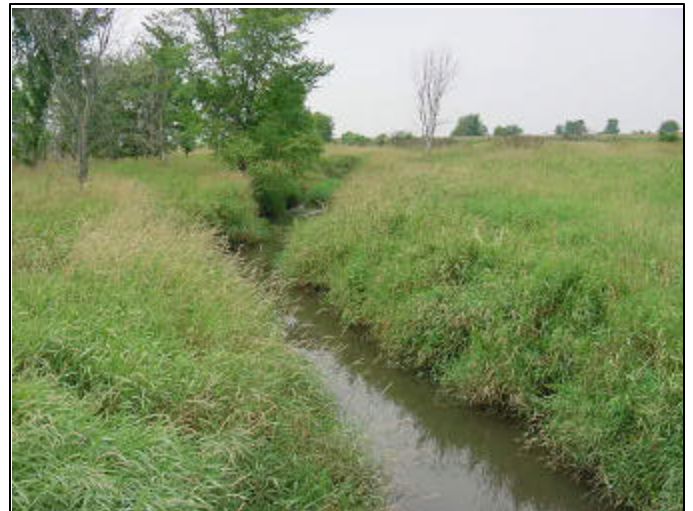
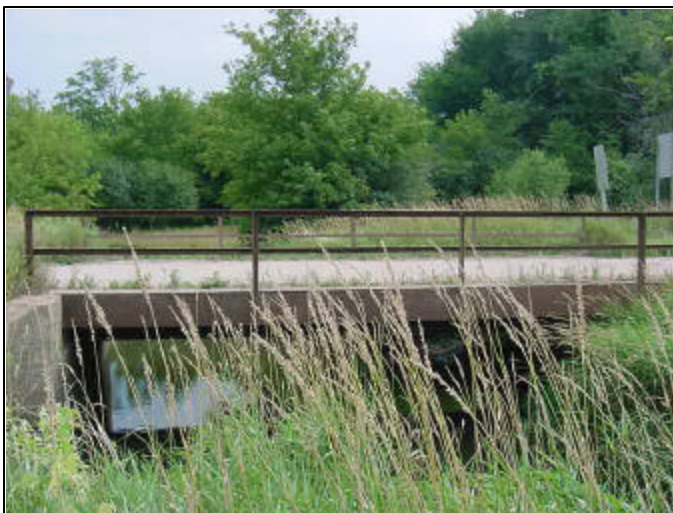
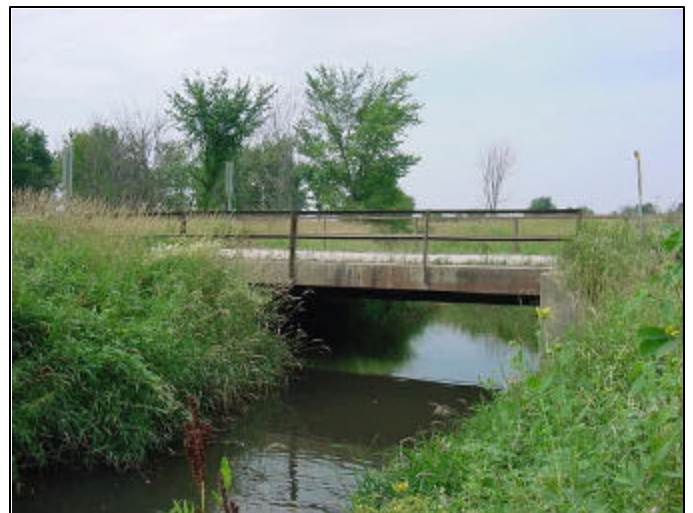
**Bridge No. 4075**  
Salem Township  
TWN 199 Cascade Creek (70<sup>th</sup> Avenue SW)

*East to west*

*West to east*

*Looking downstream*

*Looking upstream*

*Downstream of bridge*

*Upstream of bridge*

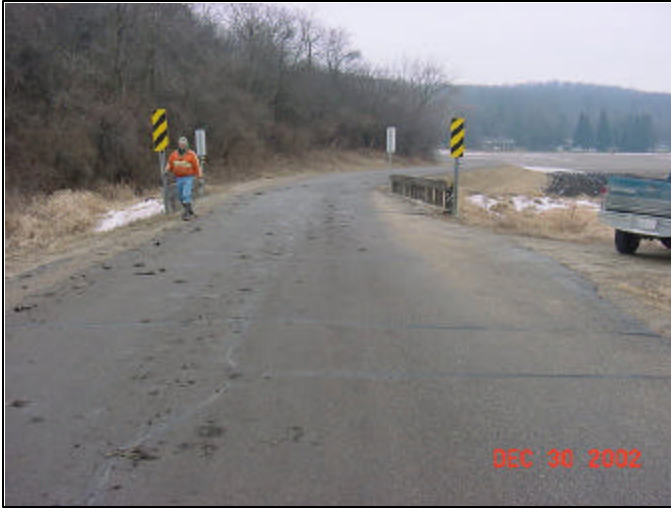
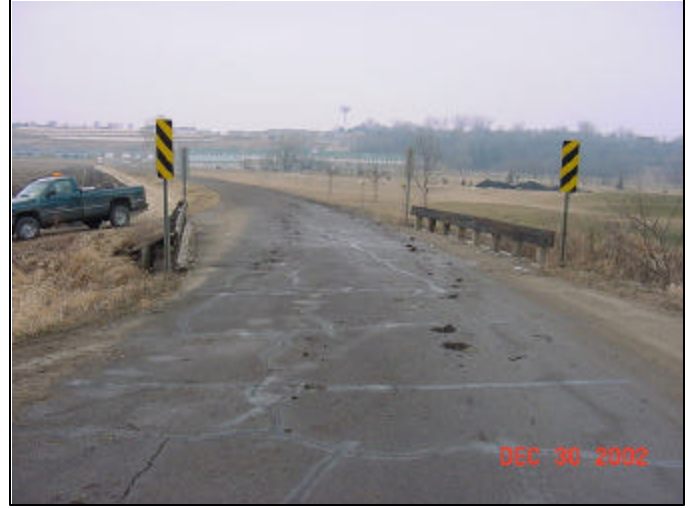
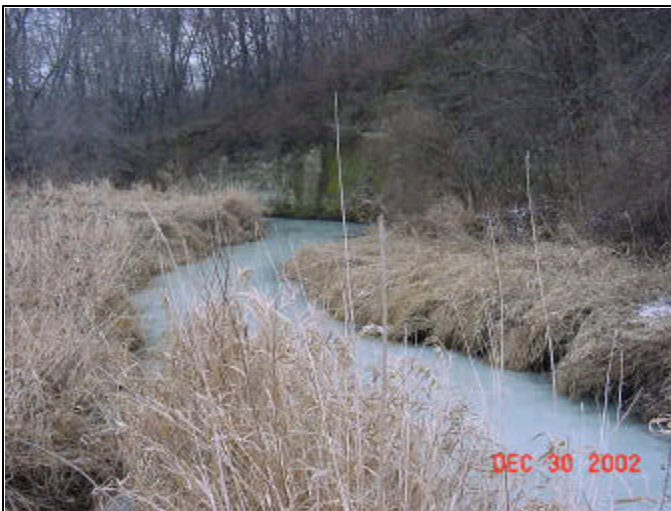
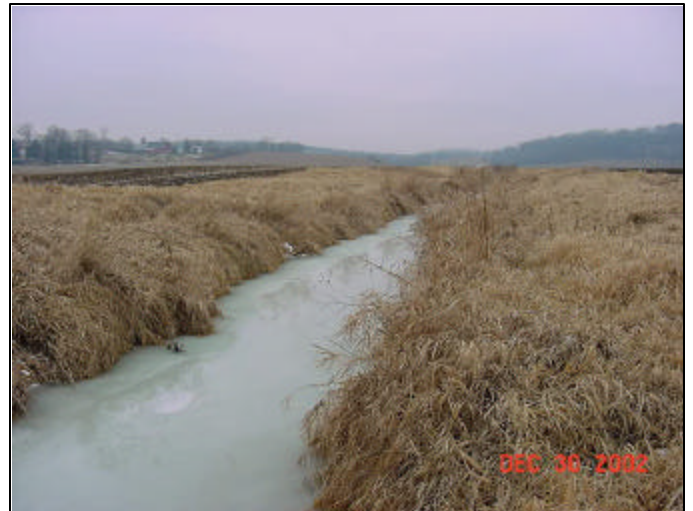
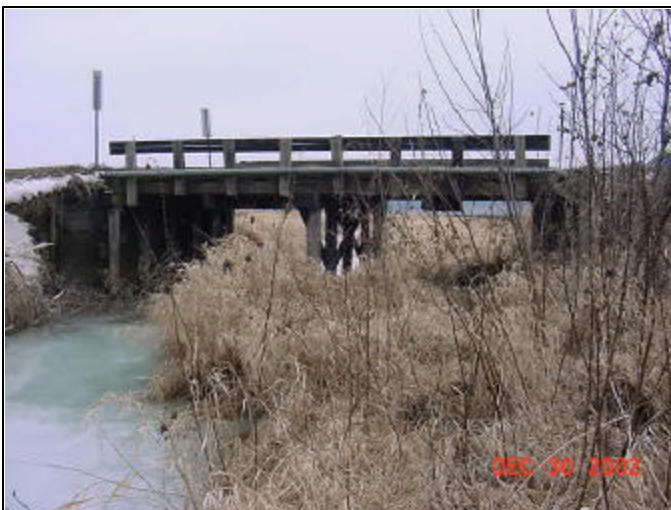
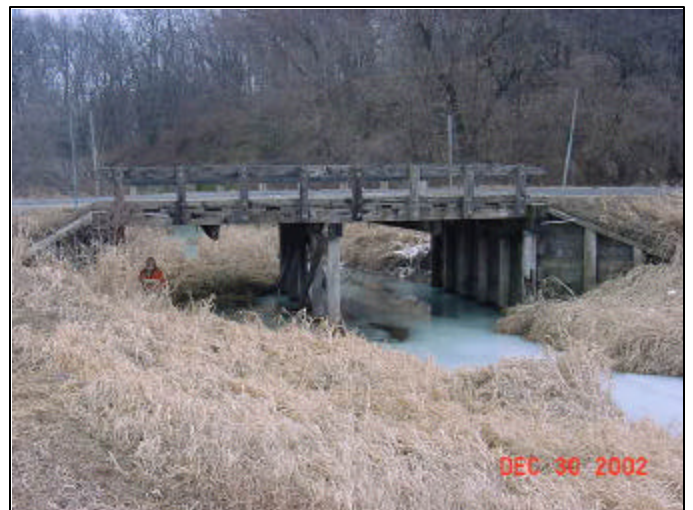
**Bridge No. L-6262**  
Rochester Township  
TWN 222 Cascade Creek (45<sup>th</sup> Avenue SW)

*North to south*

*South to north*

*Looking downstream*

*Looking upstream*

*Downstream from bridge*

*Upstream from bridge*
